Incremental rotary encoder

MNI40N

Magnetic, Non Contact

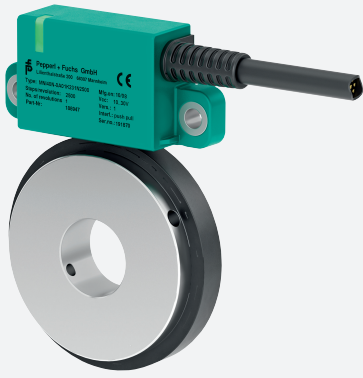
The magnetic incremental encoder MNI40 combines an exceptionally robust measurement system with intelligent diagnosis and alignment functions in the smallest space. Its highly compact encapsulated housing gives the sensor its high resistance to harsh environmental conditions. The installation-friendly design and simple guided adjustment of the sensor using two-color status LED reduces the installation time considerably.

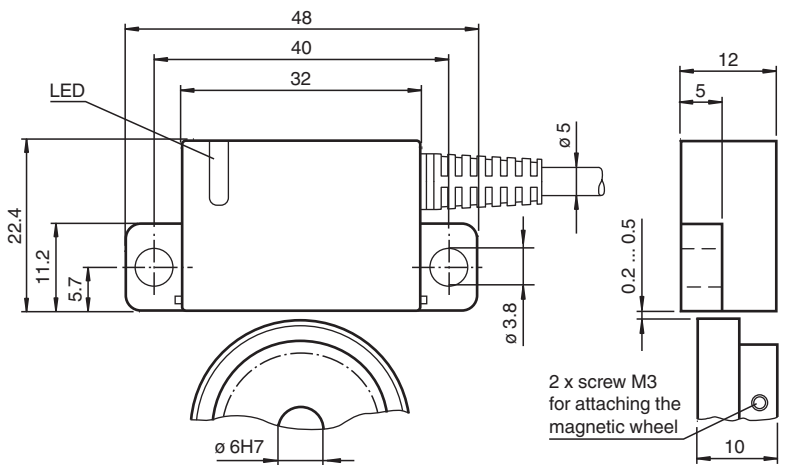
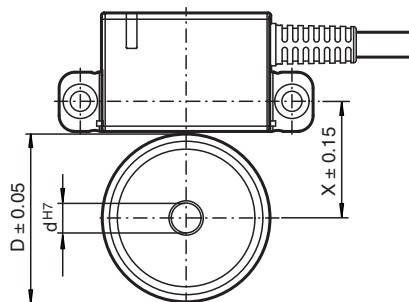
Dimensions

Poles	Ø d [mm]	Ø D [mm]	X [mm]
50	6 10 12 15	31.7	21.9
64	6 19.05 10 20 12 15	40.6	26.35
72	6 20 10 24 12 25 15 30	45.7	28.9
100	35	63.7	37.9

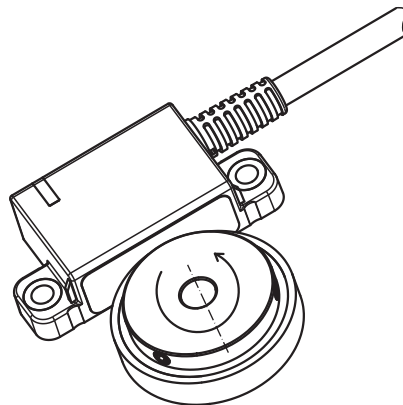
ccw - with top-view
